# STREAMBANK STABILIZATION PROJECT – NATICK, MA

## ABSTRACT

Wetlands restoration and ditch maintenance are integral parts of the Integrated Pest Management Program performed by the Central Mass. Mosquito Control Project (CMMCP). CMMCP currently works in 39 cities and towns in Massachusetts, and last year alone cleaned over 175,000 feet of ditches. One of our projects that has not quite performed to our expectations due to continued streambank failure is the subject of this article.

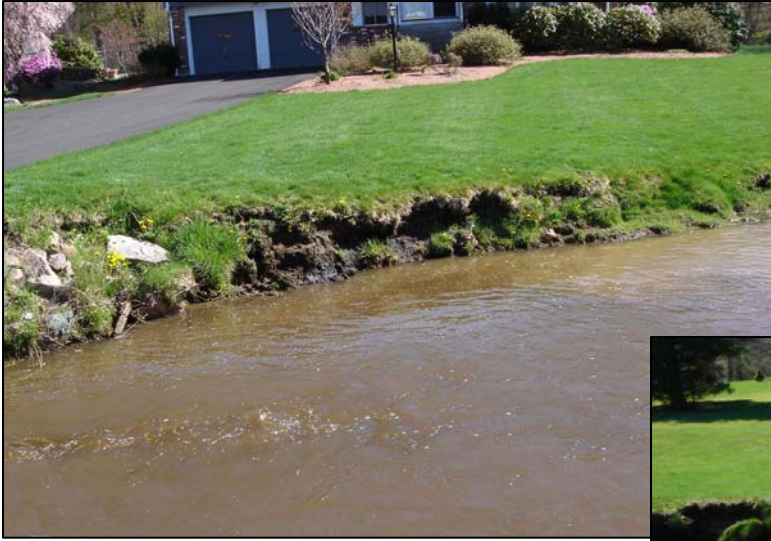
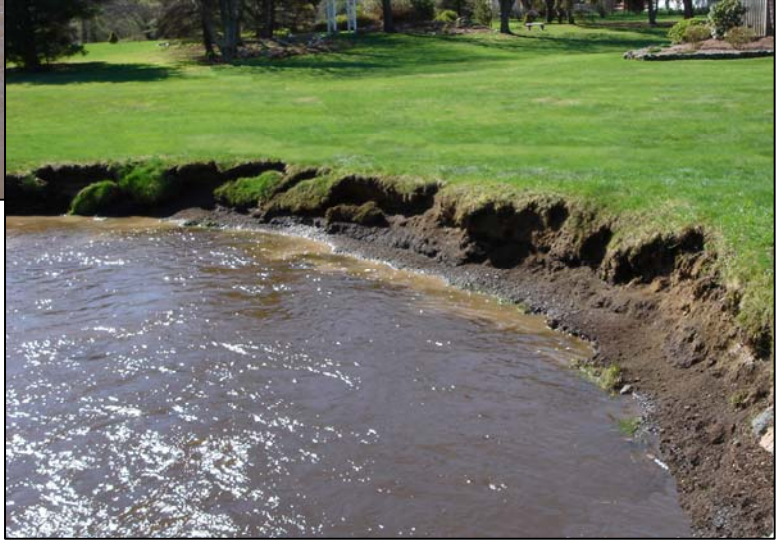
**Pre-construction**

At the subject site, located in Natick, Massachusetts, we cleaned the ditch system for the first time in 1993 using a low ground pressure excavator. Work crews were out several times since that time as part of our stream maintenance program using hand tools to keep the system free from obstructions. By 2004 the downstream section had degraded again to a point where it breached its banks and flooded over the resident's driveway.

Each time the excavator was called to action, the downstream area required removal of accumulated silt due to the failure of the streambank upstream. In our work in this system, we did not touch the 75 foot area closest to the culvert mouth due to concerns from the homeowner that he will lose a section of his lawn. This bank has failed due to poor slope (1:1) and increased pressure from residents and yard maintenance personnel. In an effort to correct this problem and as a long term solution, Northeast Environmental Solutions (NES) was contacted to give their opinion on the site and to see if a solution could be worked out. NES is based in Amherst, Massachusetts and they provide erosion control, sediment control, vegetated substrates and customized materials delivery to their customers using the newest and most efficient technologies available to them.

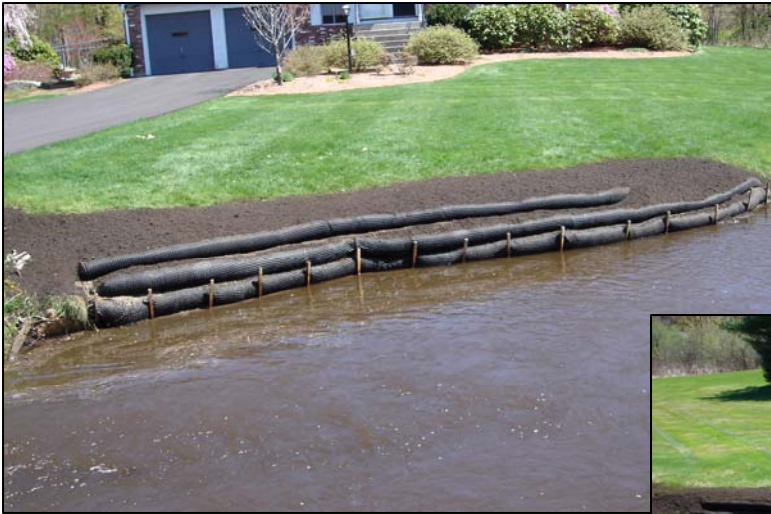
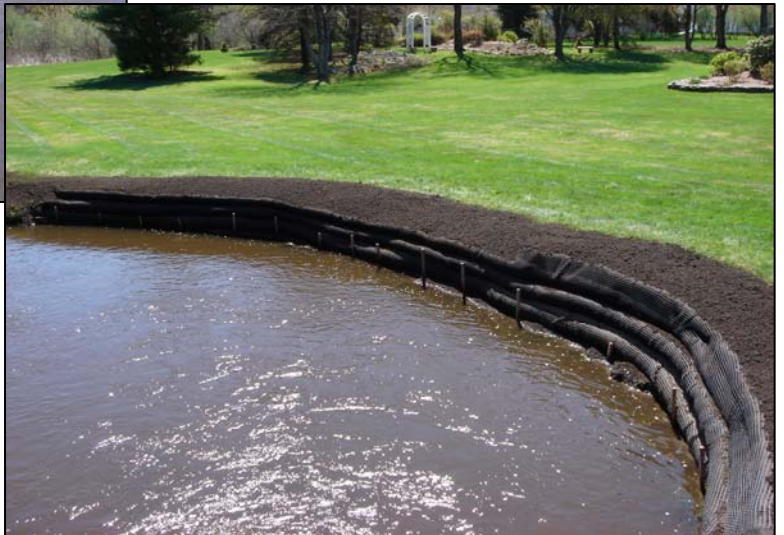
**Post construction**

streambank and then leveled, and wooden stakes were pounded into the embankment to further anchor the compost socks. A layer of geogrid was placed on the streambank, and then the first sock was filled with the gravel mixture. The remainder of the socks would then be filled with the compost mixture, and the top layers would have a grass seed mixed in also.

Filling the socks required the sock to be placed over the spray hose, using an adapter at the bottom of the hose to stretch out the sock to the correct diameter, about twelve inches. Then a knot is tied at the end of the sock. As the truck delivers the compost to the sock, the hose is pulled back. Once the first sock was in place, it was flattened slightly, and the geogrid was pulled up over the sock and anchored in the streambank with large wire staples. The remainder of the socks, now filled with compost, can be placed over this foundation, with a slight taper to the back. As each new sock is placed, compost is used as a backfill to create a flat, stable surface for the next sock. After two layers, one side of the geogrid is wrapped around the socks, and the final sock will have the top of the geogrid wrapped over it and secured with the wire staples. A compost/seed mixture used in the final socks is sprayed on top to blend in the repair with the existing surface. One side required 3 full socks, with another one running half way down. Total height is about four feet. The other side required two full socks, with one running about three quarters the distance, for a total height about 2 and a half feet.

As you may recall, we went through a rather lengthy period of drought this summer, and one failure noted was a lack of germination of the grass seed, especially in the sock face. One cause could be the drought, but the homeowner also didn't live up to his part of the bargain, the area was not watered enough. It was also necessary to place a barrier around the area for a short time to alert the grounds crews to stay away and let the area stabilize. NES reseeded the site two times, June and October, and in October noted a small area of undercutting that was fixed using a few stones from the area. The second seed mixture used was a rice cut grass which was recommended by NES. The site has now filled in nicely, with the sock faces the only areas left to be reseeded. Other options for the sock face included wetland plants like red stem dogwood, etc.
